GEOLOGIC MAP AND SECTIONS OF THE SAN ROQUE MINE, HUANCVELICA QUICKSILVER DISTRICT, PERU
PLANO Y PERFILES GEOLOGICOS DE LA MINA SAN ROQUE, DISTRITO MERCURIFERO DE HUANCVELICA, PERU

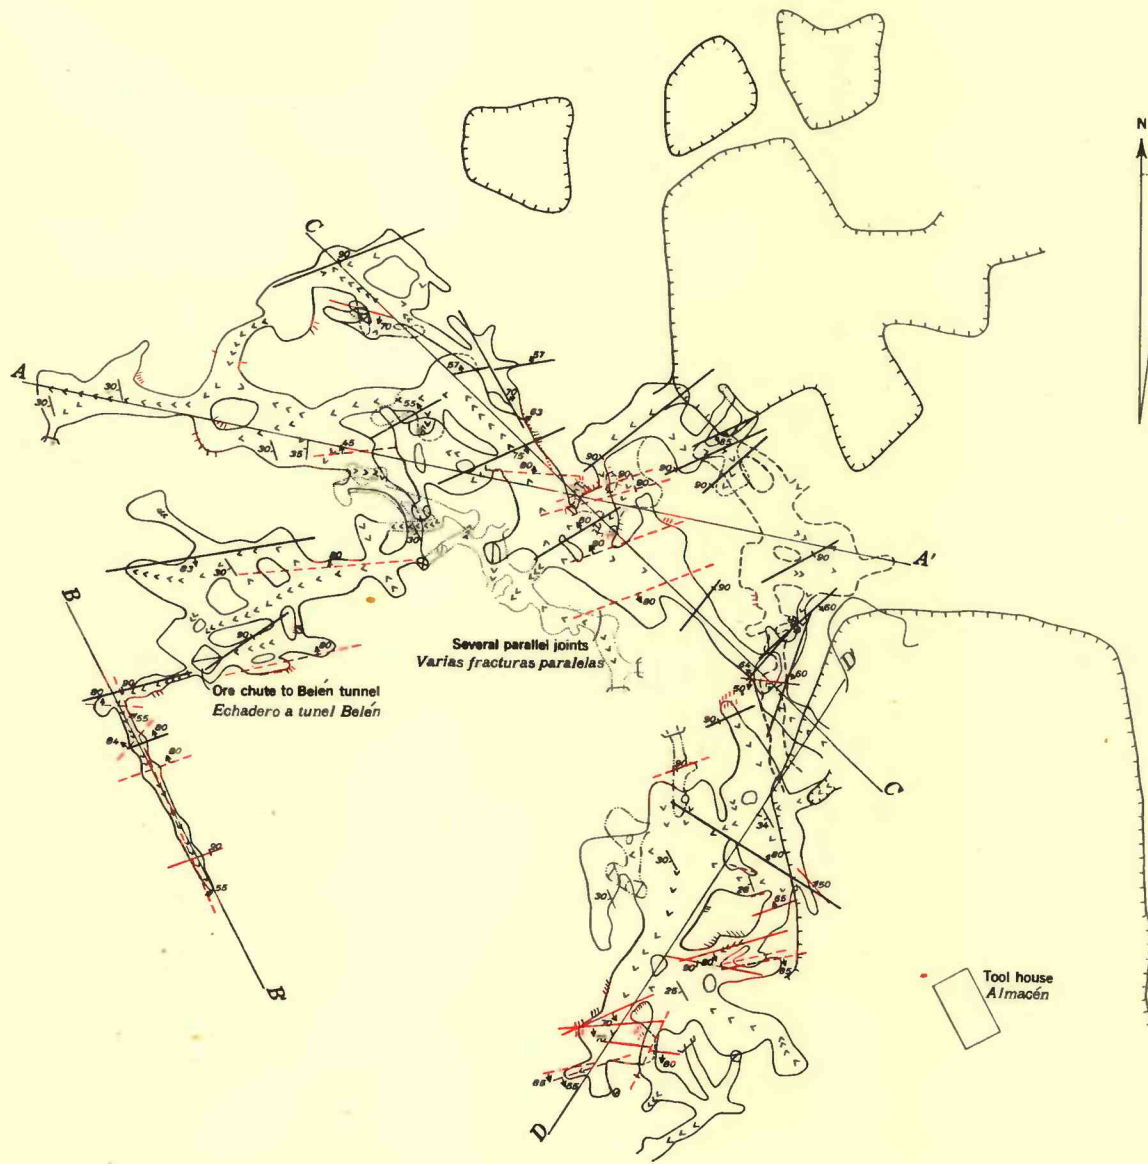
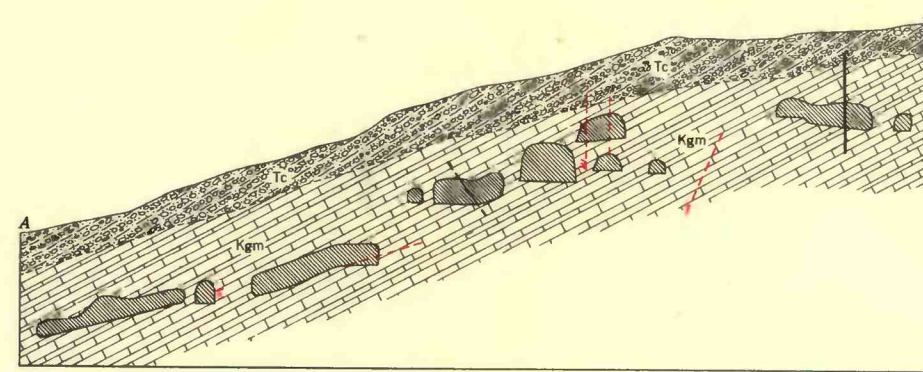
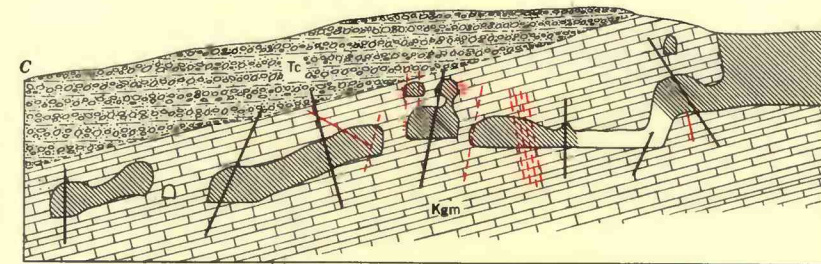
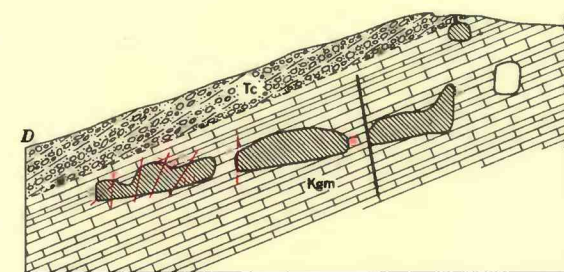
Surveyed with compass and tape
Plano levantado con brújula y cinta
